PHASE I SMALL BUSINESS INNOVATION RESEARCH (SBIR) PROGRAM

**PHASE I OPTION PROGRAM
FINAL REPORT
PERIOD 9/16/2002 TO 2/16/2003**

**EMBEDDED SENSOR TECHNOLOGY FOR SOLID ROCKET
MOTOR HEALTH MONITORING**

MICRON REPORT NO: 02-221B

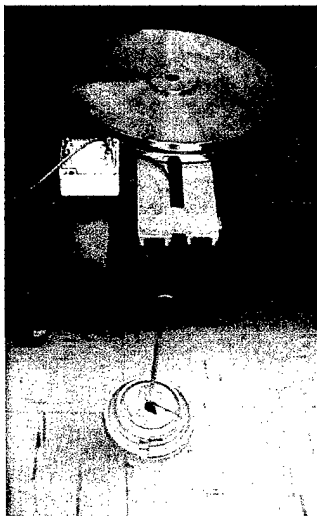
Figure 5. Test Rig

Calibration checks of the sensor after casting of the propellant grain is not possible, therefore it is essential that the units used for long term health monitoring are accurate and stable. Any sensitivity change or zero shifts in the sensor output would be indistinguishable from changes in the measured bond stress. Long term changes in balance with no sensor stress have also been run and were found to be acceptable. To test the stress stability of the current system a cantilever constant load test consisting of a static load applied to the sensor diaphragm was initiated and ran for 55 weeks before the bond broke. The stress was applied to the sensor via a hard rubber interface and hanging weights. Extra care was used to ensure that the bonded surface area was limited to be that of the active surface area of the sensor diaphragm. The test rig was exposed to the ambient temperature variations and the data downloaded at regular intervals. The loading fixture is shown in Figure 5 and a local view of the sensor under tension load shown in Figure 6.

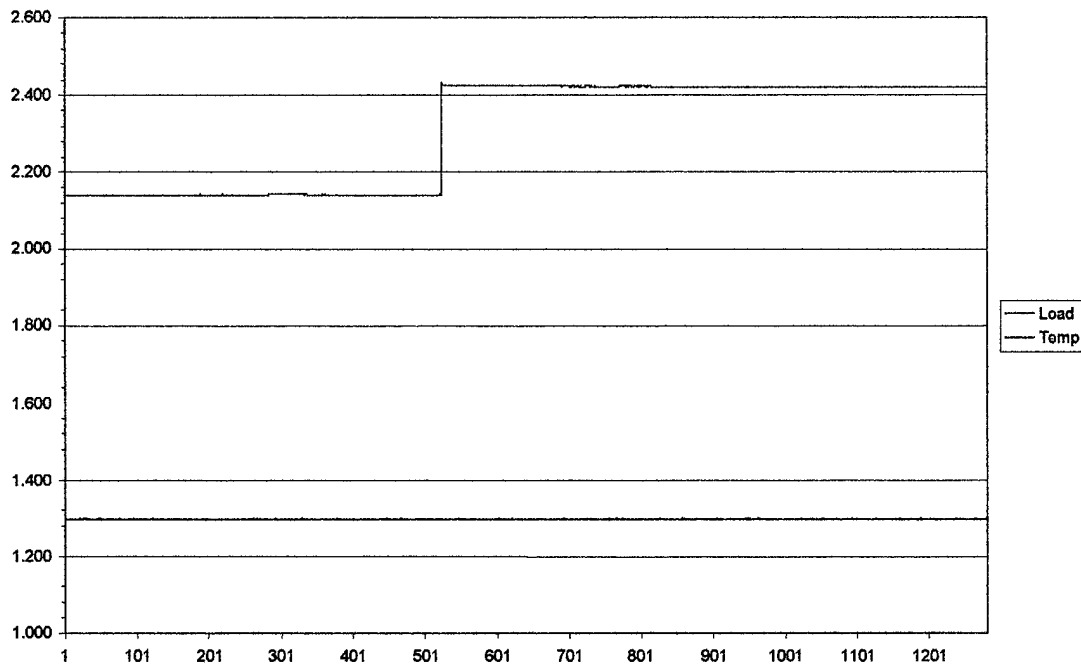
Figure 7. Loading Sequence

The first hour of the loading sequence on the 21st December 2001 is shown in Figure 7 in logger output of volts and a scan rate of five seconds.

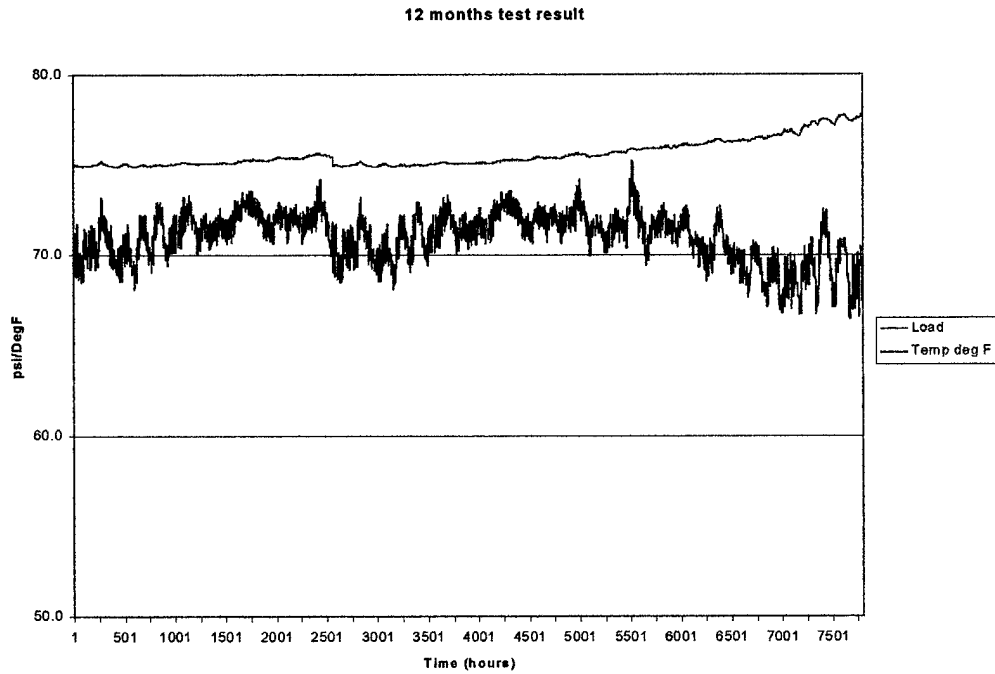
Figure 8. Long Term Stability Test results

The plot of the results for the next twelve months are given in Figure 8 in engineering units which shows that the variation of output is 75 psi to 78 psi for the load, together with the ambient temperature variations. The trend of the load follows the average increase in the ambient temperature until towards the end when there is a significant increase. It is assumed this is due to progressive bond failure at the sensor/rubber interface. Inspection of the bond line gave signs that the edge of the interface around the sensor was separating. This was confirmed because during the last few weeks of sensor output, as given in Figure 9, it can be seen that the load increases as the bond area decreases at an increasing rate until final failure. The recorded peak load as shown in Figure 10 was over 200 psi. With the scan rate of one hour the actual peak value may have been missed and larger. A picture of the bonded area of the sample and shim is given in Figure 11.

The sensors zero value after a temperature correction had increased by 3.8 psi due to creep in the bonds of the semiconductor gages which is considered acceptable after over a year under load at ambient temperature. The sensitivity value, the more important characteristic for long-term stability, showed a change of level less than 0.1% well inside the initial values measured over the temperature range.
